Manhole Inspection Summary

Manhole # S07II2015MH

Insp Date: **7/6/06 1:43 PM**

Location Address: **2404 LINCOLN AVE**

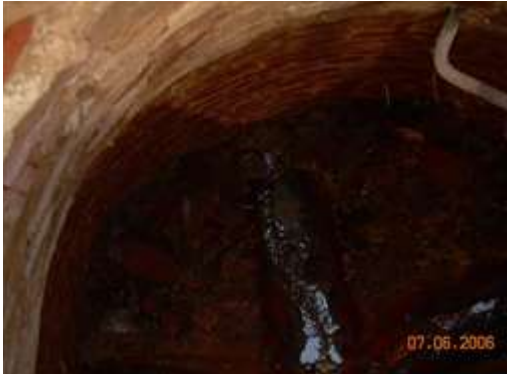
Defect

Condition: ☐ Sound ☐ Cracked ☐ Root Intrusion ☐ Deteriorated ☐ Leaks ☒ Debris

Bench debris

bench and channel debris

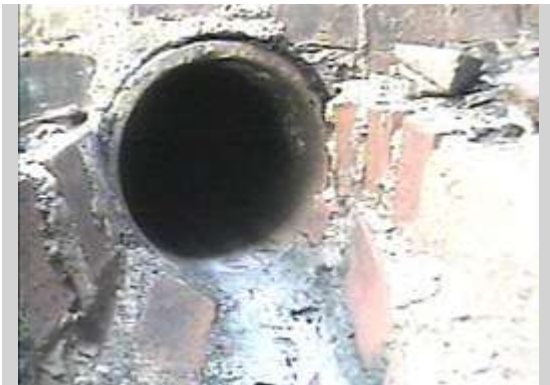
8 in. Circular Gravity Sewer Pipe In @ 3 O'Clock

Infiltration: **Evidence** Pipe Seal Cond: **Unknown**

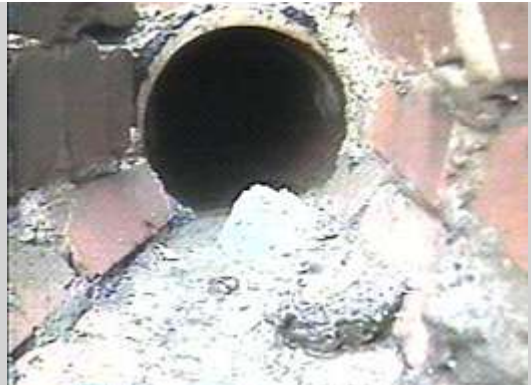
8 in. Circular Gravity Sewer

Channel debris

Infiltration: **Evidence** Pipe Seal Cond: **Unknown**

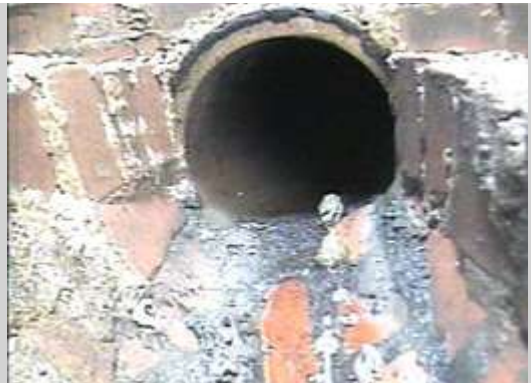
8 in. Circular Gravity Sewer

Infiltration: **Evidence** Pipe Seal Cond: **Unknown**
